CAPITAL RESERVE STUDY

← CATEGORY II: UPDATE WITH ON-SITE REVIEW →

SEAPOINTE VILLAGE MASTER ASSOCIATION COMMUNITY ASSOCIATION 9901 SEAPOINTE BOULEVARD, WILDWOOD CREST, NJ 08260

Fiscal Year: 2017
Fiscal Year
Date Span: April 1, 2017 - March 31, 2017
Care of: Seapointe Village
Job Number 3854.0006
Prepared: May 2017
Finalized: October 2017

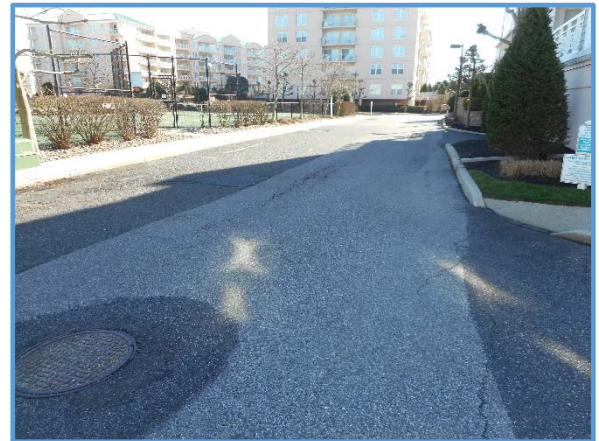
Asphalt Pavement

The existing surfaces of the roadway were observed to be in varying conditions. The existing asphalt was observed to contain deteriorated surfaces, potholes, and cracking at Memphis Avenue. The Ibis Lane parking area appeared to be in better condition than other asphalt roadways and parking areas. The remainder of the asphalt surfaces were experiencing rough surfaces throughout, with areas of settlement observed by the curb and roadway junction. There are a few areas where patches were found indicating previous repairs at the curbs and inlets.

Prior to the installation of a new wearing course, milling, crack repair, and reconstruction of base course failure are expected to occur. The costs to perform these additional operations are included in the unit cost provided within the schedule.

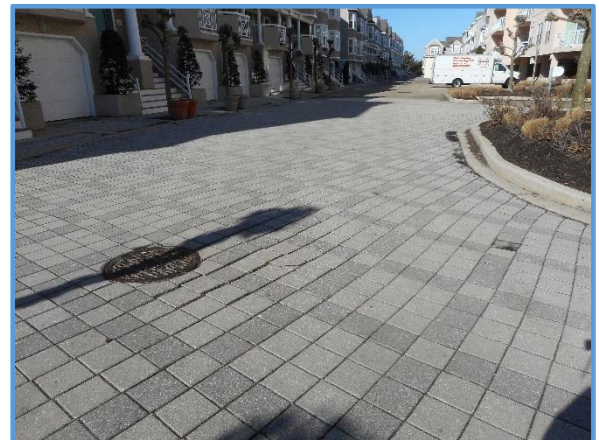
Concrete Pavers

Precast concrete pavers are interspersed throughout portions of roadways within Seapointe Village including the gated entrance way on Seapointe Boulevard, the parking lot access behind the Ibis building, the Ibis Lane terminus, and at the south elevation of the North Beach Building. The pavers have a thirty (30) year typical useful life. The pavers were observed to be in average condition with settlement in areas near the storm inlets, water ponding, and areas of separation between the pavers.

Regular maintenance of the pavers includes power washing, replenishment of the sand in the joints, and resetting of displaced pavers. Any trip hazards and areas presenting *safety* hazards should be replaced immediately to eliminate the hazard.

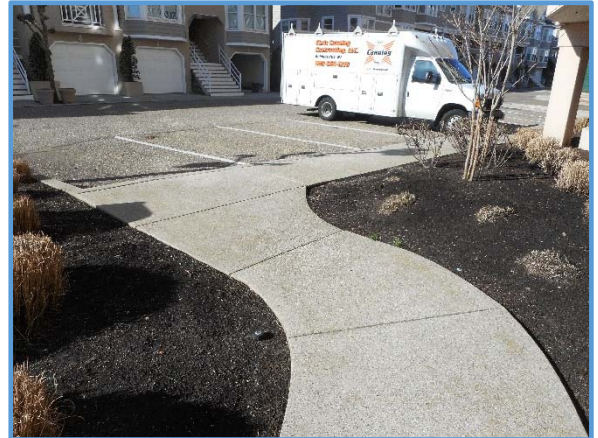
Concrete Sidewalk

The sidewalks at the community are constructed of Portland Cement concrete, which has a typical useful life of thirty (30) years. The sidewalks were observed to be in average condition with deficiencies including cracks, spalling, and displaced sections.

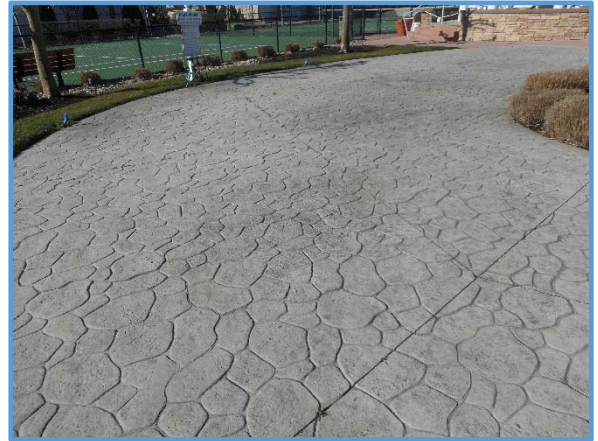
Stamped Concrete

Stamped concrete, often referred to as textured or imprinted concrete, is concrete that replicates stones such as flagstone, tile, and brick. Stamped concrete can be installed with a variety of different colors. Stamped concrete has a typical useful life of thirty (30) years and is located near the Ibis pool and playground area. The stamped concrete was observed to be in average condition.

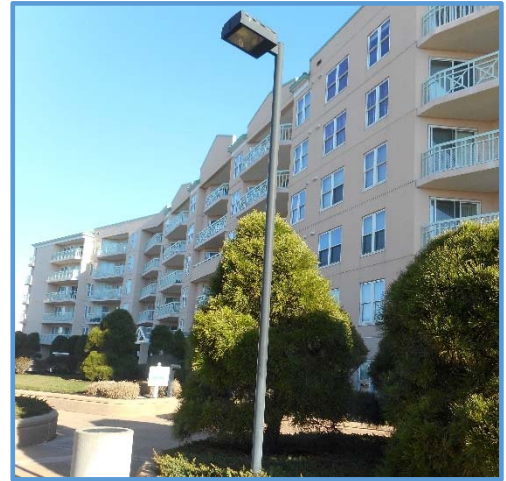
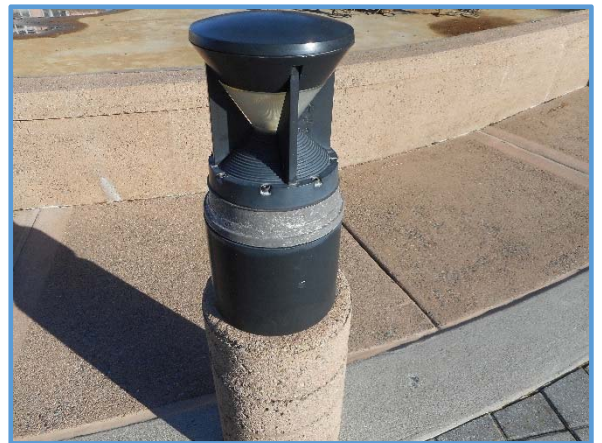
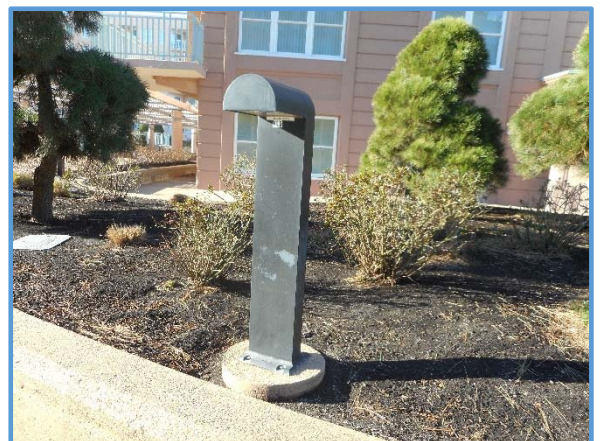
The common areas, including the community roadways and walkways, are illuminated with a combination of twenty (20') foot aluminum shoebox fixtures and aluminum bollard lights. Exterior lighting has a twenty-five (25) year typical useful life. The lighting was observed to be in average condition, experiencing minor corrosion on the surfaces and fading.

The pricing reflected in the schedule anticipates that all the light fixtures within the community will be replaced with those of the same size, type, and intensity. The lighting replacement cost does not include the replacement of wiring or conduit.

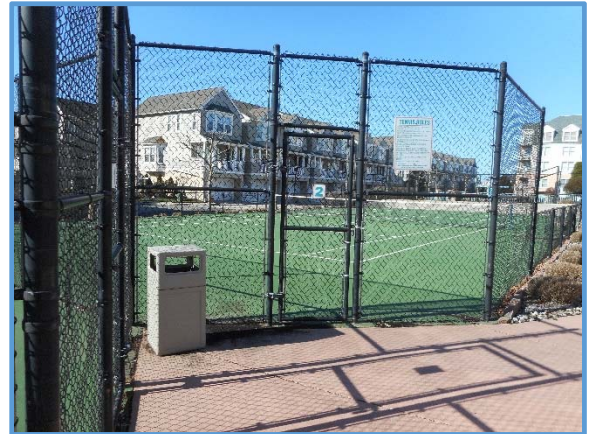
10' Chainlink Fence

Ten (10') foot high and four (4') foot high vinyl coated chainlink fencing encompasses both tennis courts adjacent to the Ibis building as well as the basketball court. Six (6') foot vinyl coated chainlink fencing encompasses the pool heaters near the Centre Court portion of the community. Fencing of this type has a twenty-five (25) year typical useful life. The chainlink fencing was observed to be in average condition, showing signs of corrosion on the fasteners and poles, finish failure, and crushed sections of chainlink between the tennis courts.

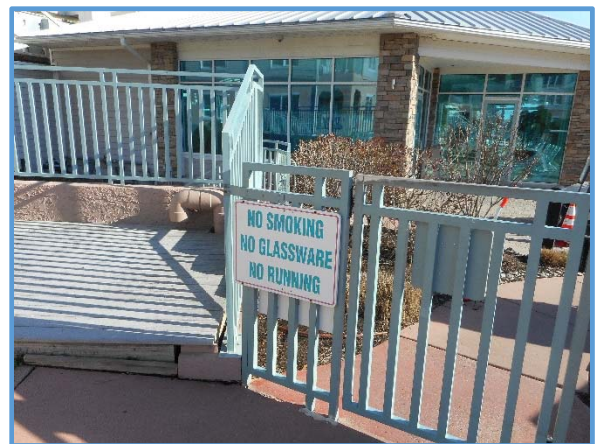
4' Aluminum Fence (Centre Court)

Four (4') foot high aluminum fencing exists at a majority of the recreational areas on-site. These types of fences have a typical useful life of twenty-five (25) years. The aluminum fencing was observed to be in average condition with areas of corrosion and finish failure present on the fence surfaces.

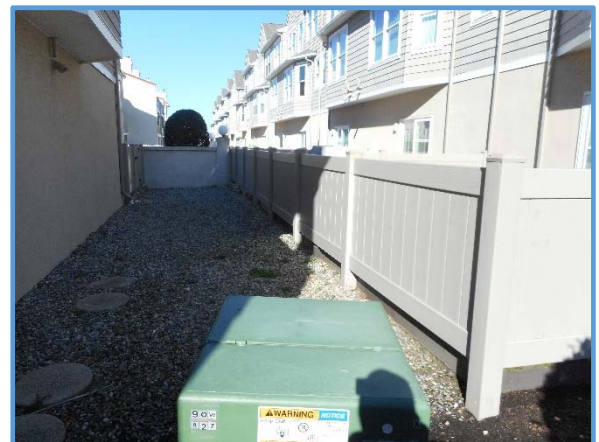
Vinyl Privacy Fencing

Vinyl privacy fencing of varying heights are located along portions of the perimeter of the townhomes and between unit patios. The Association has been replacing portions of existing wood fence with vinyl fence behind the townhome buildings. Vinyl fencing also exists at the rear of the single family homes along Dune Drive. Vinyl fencing has a typical useful life of twenty-five (25) years. The vinyl fencing was observed to be in average to above average condition.

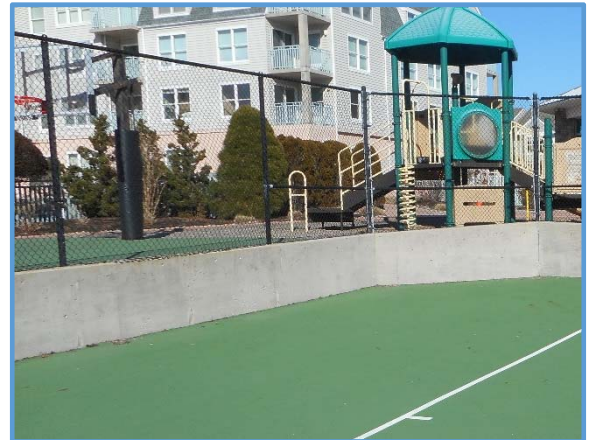
Poured Concrete Retaining Wall

A poured concrete retaining wall is located at the west elevation of the tennis courts and was observed to be in above average condition, appearing to have been installed sometime after the inception of the community.

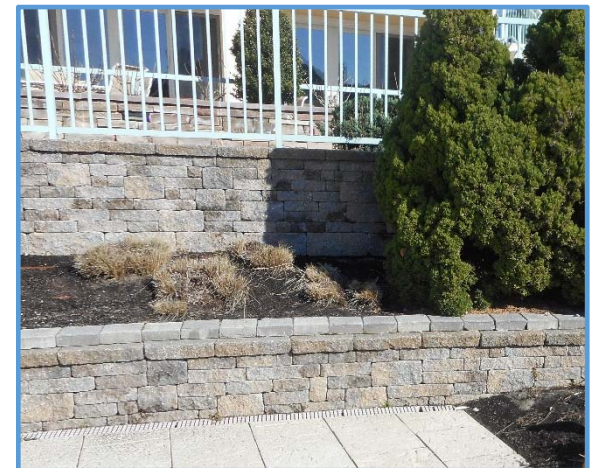
Concrete Field Stone Retaining Wall

Concrete field stone retaining walls exist at the Ibis pool area and Garden pool area. These walls appeared to be in average condition, showing signs of minor shifting.

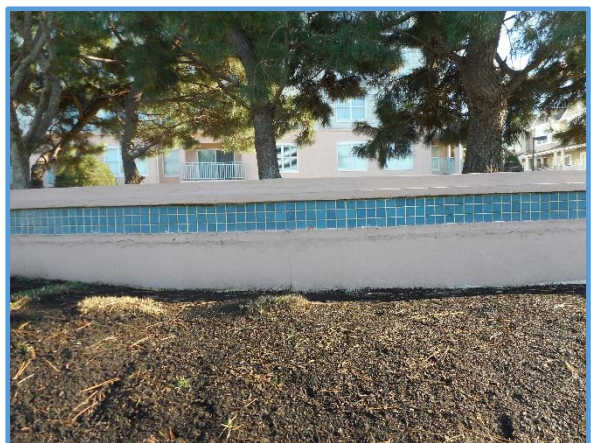
Masonry Concrete Retaining Wall

Masonry concrete retaining walls constructed of concrete masonry units (CMU) and finished with stucco and ceramic tile are interspersed throughout the community. These types of retaining walls were observed to be in varying conditions, with many of the walls possessing signs of cracking throughout. During inspection, it was noted that the Dune Drive entry wall appeared to be displaced, causing the wall to lean toward the parking lot.

It is recommended that the retaining walls are inspected on a regular basis. Any retaining walls posing possible *safety* hazards should be repaired or replaced immediately to eliminate said hazards.

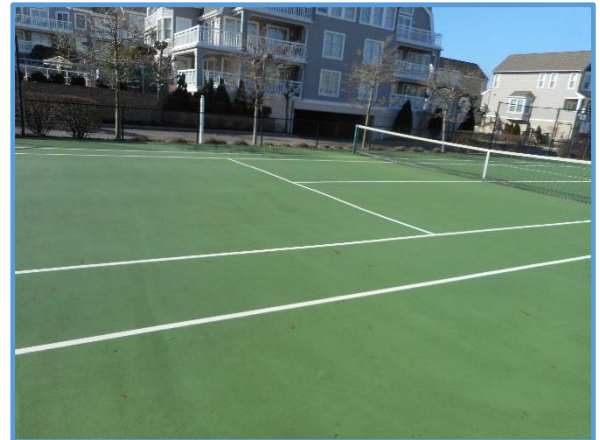
Tennis Court Surface

Two (2) tennis courts are located within the community and are constructed of bituminous concrete. Funding for the resurfacing of the court followed by replacement has been included in the replacement reserve schedule. It is recommended that the courts are recoated with a minimum of two (2) coats of latex-acrylic paint every seven (7) years to seal minor surface cracks and deficiencies and also to rejuvenate the playing surface. Tennis courts have a typical useful life of twenty (20) years, after which time they will require an overlay of new asphalt or full reconstruction, depending on their condition. The tennis courts were observed to be in average to below average condition with deficiencies including spalling, cracking, peeling, and ponding water.

The unit costs for tennis court recoating includes reconstruction of significant cracks, crack sealing, and application of a new color coat. The replacement cost includes a complete removal and replacement of the asphalt courts.

To promote cost-effectiveness and prevent possible damage to a newly-installed playing surface, it is anticipated that each court's fence will undergo replacement coinciding with the next replacement of the court's playing surface.

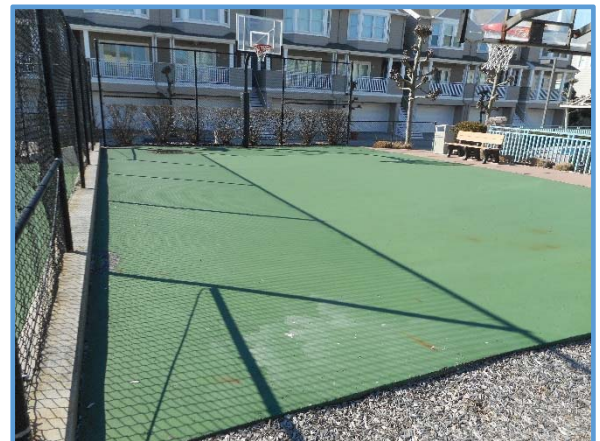
Basketball Court Surface

There is one basketball court located within the Ibis recreational area. The court is surfaced with bituminous concrete. Funding for the replacement of the court followed by resurfacing has been included in the schedule. It is recommended that the court is resurfaced every seven (7) years to seal minor cracks and deficiencies in the surface and also to rejuvenate the playing surface. Basketball courts have a typical useful life of twenty (20) years after which time they will require an overlay of new asphalt or full reconstruction depending on their condition. The basketball court surface was observed to be in average condition, experiencing staining and areas of ponding water.

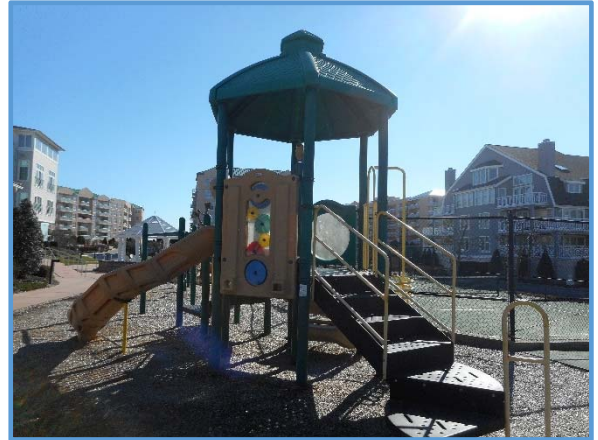
Tot Lot Play Structure

One (1) tot lot is located adjacent to the Ibis outdoor pool area. The tot lot consists of one (1) modular climbing structure constructed of heavy duty vinyl and a four (4) seat swing set. The play structure and swing set have a typical useful life of twenty-five (25) years and were observed to be in average condition. Fading, staining, and finish failure of the tot lot components were observed during inspection.

The addition of safety bedding to prevent fall hazards will be funded through the operating budget.

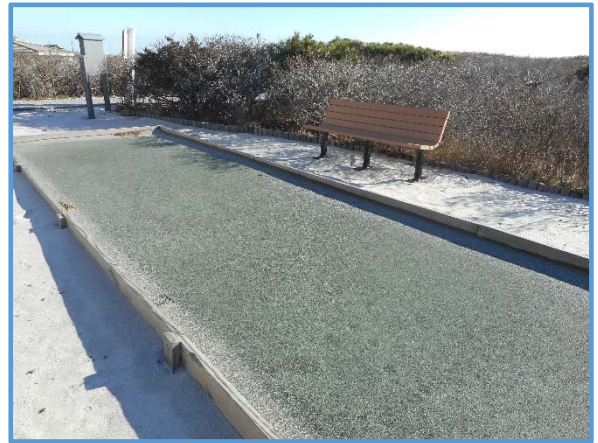
Bocce Court
(Ocean Side)

One (1) bocce court is located adjacent to the north walkway to the beach and was observed to be in average condition. The bocce court consists of dimensional lumber edging and a Har-Tru Claytech playing surface. Exterior wood products possess a fifteen (15) year typical useful life. It is anticipated that the playing surface will be maintained through the maintenance budget.

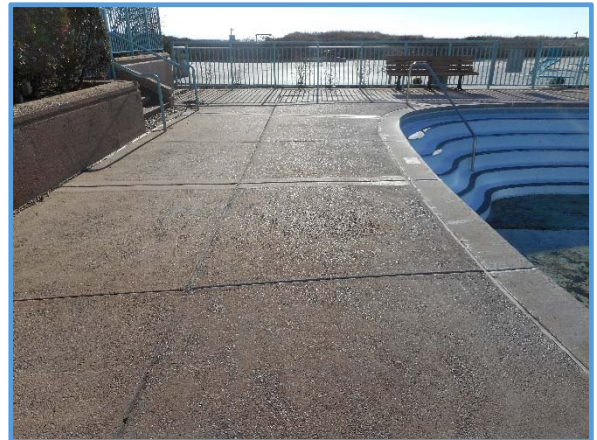
Concrete Pool Deck
(Ocean Side Pool Area)

All of the pool decks are constructed of concrete, which has a typical useful life of thirty (30) years. Some of the concrete is colored and/or stamped with a decorative design. The pool decks were observed to be in average condition, with the exception of the Garden pool deck, which was observed to be in below average condition in certain areas. The pool decks were experiencing areas of cracking, spalling, and displaced sections.

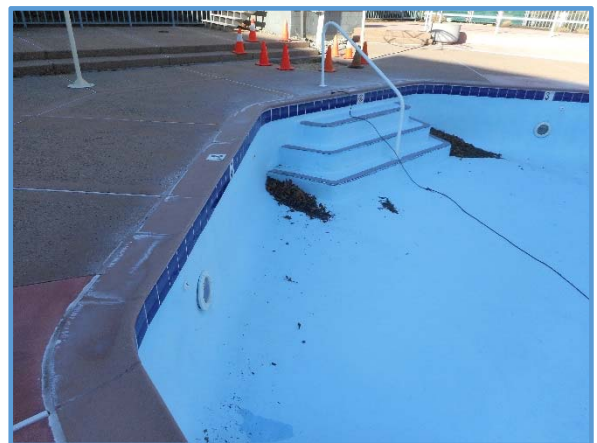
Pool Surface & Coping
(Garden Pool Area)

The interior surfaces of the pools are finished with plaster. Concrete pool surfaces typically require resurfacing every seven (7) years to maintain a water tight envelope and a smooth surface for swimmers. The pools are bordered with a concrete pool coping and ceramic waterline tile. With the exception of the Ibis pool, all pools/spas were drained for the winter. The pool surfaces were observed to be in average to below average condition. Signs of spalling, cracking, and wear were observed at the pool surfaces. The pool copings were observed to contain areas of cracking. The waterline tile appeared to contain areas of cracking, grout staining, and broken sections. During inspection, it was noted that the waterline tile near the top of the slide of the Centre Court pool contained sharp edges from cracking.

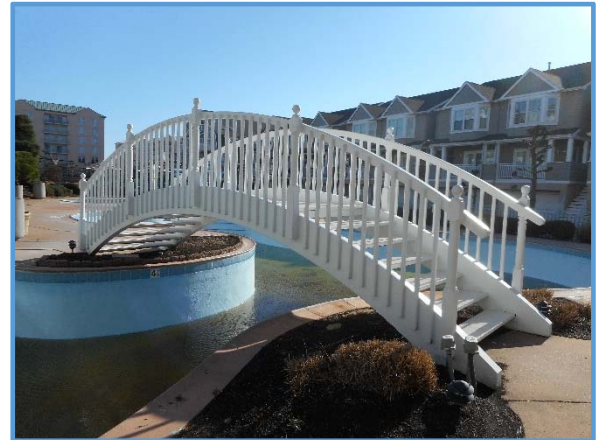
*Wooden Pedestrian Bridge
(Centre Court Pool Area)*

A wood pedestrian bridge is located at the pool area of the Centre Court building. Bridges of this type possess a fifteen (15) year typical useful life. The condition of the bridge was difficult to assess due to the heavy coat of paint on the entire structure. Metal braces under the stair treads were observed to contain severe corrosion. During inspection, it was noted that the bridge seemed unstable when crossing the structure. It is recommended that the bridge is further assessed to ensure its structural integrity and safety for residents. According to the Association, bridge structures are evaluated during the community's pre-season inspection and maintenance program. Any issues that arise are anticipated to be addressed and remediated during that time.

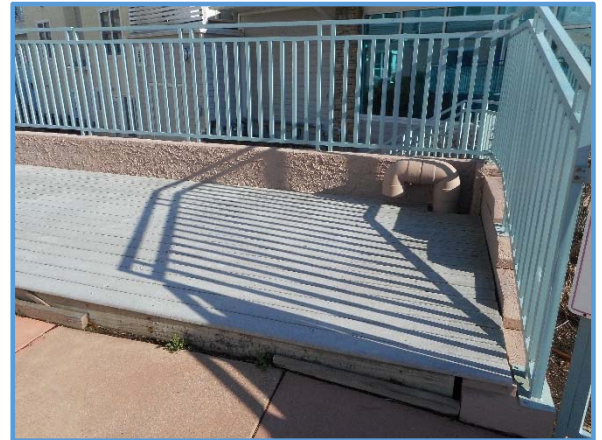
*Composite Decking
(Centre Court)*

The composite decking located at the Centre Court pool area was observed to be in average condition, experiencing wear and minor sagging between the joists.

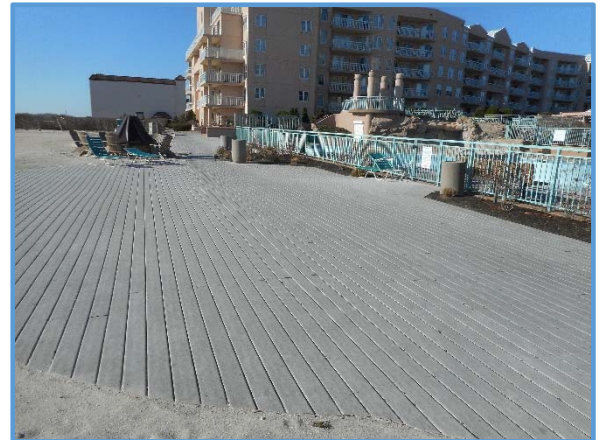
*Composite Decking
(Ocean Side)*

The composite decking on the ocean side of the community was observed to be in varying conditions, with deficiencies including fading throughout, areas of sagging between the floor framing, and displaced sections.

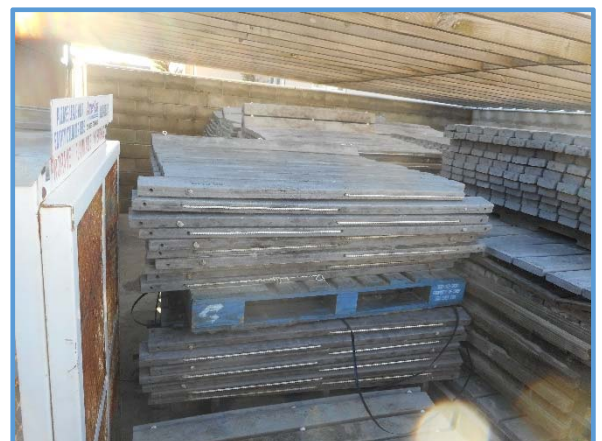
Rollout Composite Decking

The modular rollout composite decking that is laid out on the beach in the summer season was stored during the time of inspection. The decking appeared to be in average condition, however, not all sections were able to be assessed in their entirety. The Association has extended the modular rollout composite decking in February of 2013 and in 2016. Additional line items have been included in the schedule to account for the newer sections of decking.

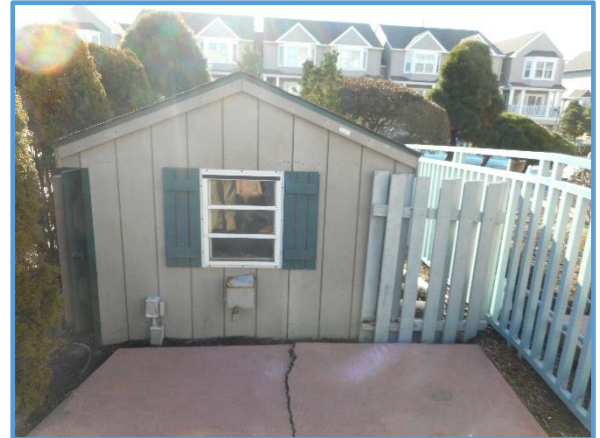
*Pool Storage Shed
(Centre Court)*

One pool equipment shed is located at the Centre Court pool area. This shed contains dimensional asphalt shingles and T-11 (wood) siding. The shed was observed to be in average condition, showing signs of staining on the exteriors.

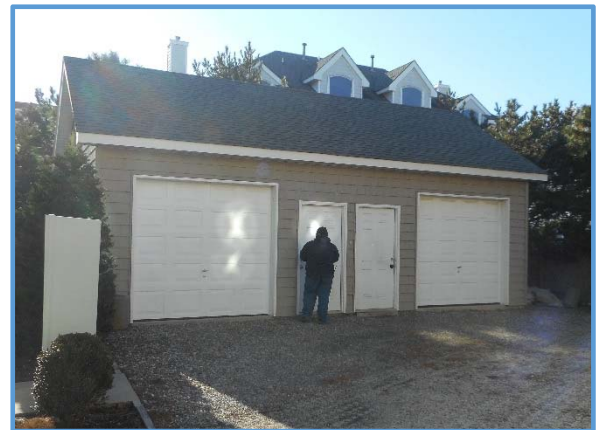
*30' x 20' Storage Shed
(Between Townhomes 300 & 400)*

A large storage shed weatherproofed with dimensional asphalt shingles and vinyl cedar impression siding is located in between the 300 and 400 townhome buildings. The shed was observed to be in average condition, showing signs of staining on the vented vinyl soffit.

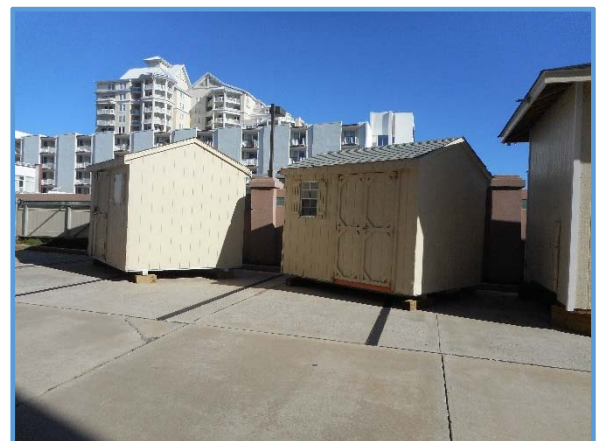
*10' x 12' Storage Sheds
(Ocean Side)*

Three (3) 10' x 12' storage sheds are located on the ocean side of the community and are weatherproofed with dimensional asphalt shingles and T1-11 (wood) siding. The sheds were observed to be in varying conditions with varying remaining useful lives. Their expected replacement is reflected in the schedule respectively.

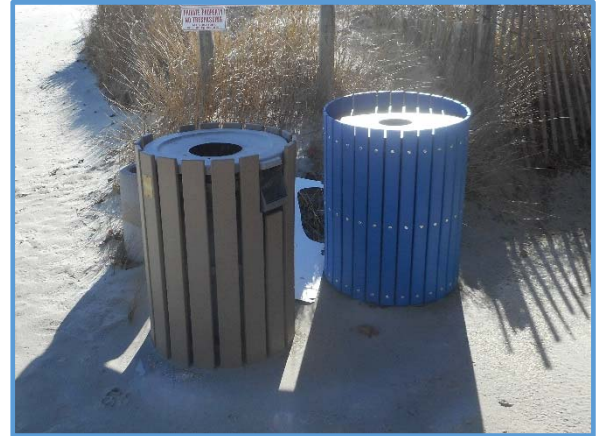
Trash / Recycling Receptacles

Trash and recycling receptacles are interspersed throughout the community and have an eight (8) year typical useful life. The receptacles are constructed of varying materials including composite slats, metal framing, and vinyl panels. The receptacles were observed to be in average condition, showing signs of corrosion on the fasteners.

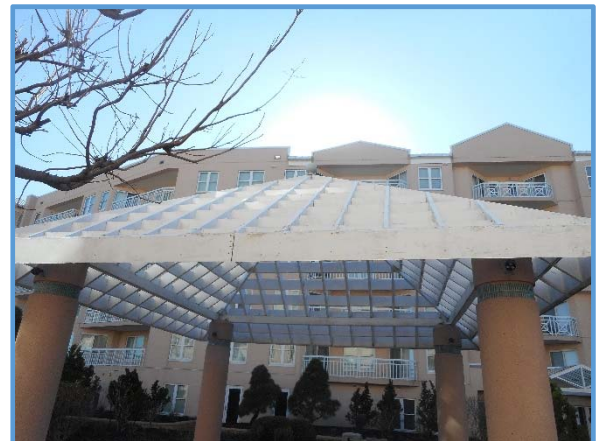
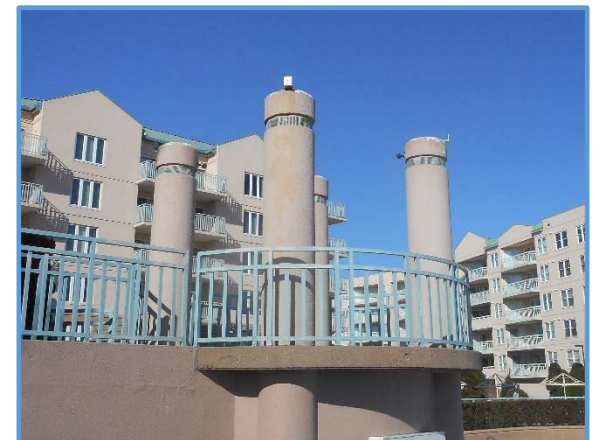
The larger wood gazebo was observed to be in average condition, showing signs of minor finish failure. The small wood gazebo is in need of replacement during the first year of the study. The dimensional lumber that comprised the roof system of the gazebo had been removed because of significant damage. The concrete masonry pillars associated with the wood gazebos are not anticipated to be replaced during the scope of this study. The unit costs only reflects the wood roof structure portions of the gazebo.

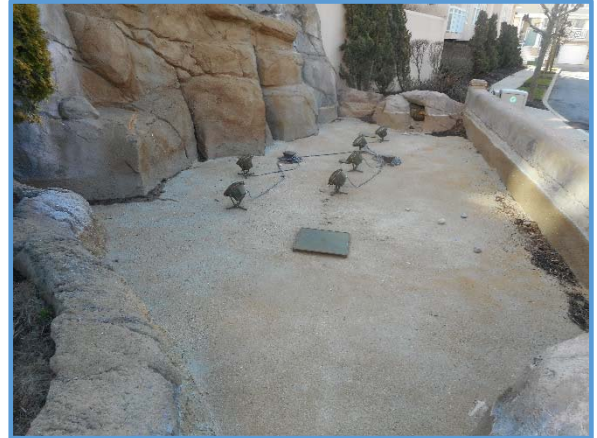
Lagoon
(South Beach)

A total of five (5) lagoons are interspersed throughout the community. The lagoons are comprised of concrete surfaces and artificial stone. Mechanical and electrical components associated with the lagoons include pumps, fountains, and underwater lighting. Of the five (5) lagoons within the community, two (2) are original to the construction of Seapointe Village. These lagoons are located near the Garden building and off Memphis Avenue, near the North Beach building. The original lagoons were observed to be in below average condition, experiencing water staining, cracking, and broken sections of the surfaces. The remaining three (3) lagoons are located near the South Beach building, at the east elevation of the Pinnacle building, and at the south elevation of the North Beach building. The newer lagoons were observed to be in below average condition, showing signs of cracking along the surfaces and areas of staining.
