CAPITAL RESERVE STUDY

← CATEGORY II: UPDATE WITH ON-SITE REVIEW →

SEAPOINTE VILLAGE MASTER ASSOCIATION COMMUNITY ASSOCIATION 9901 SEAPOINTE BOULEVARD, WILDWOOD CREST, NJ 08260

Fiscal Year: 2017
Fiscal Year
Date Span: April 1, 2017 - March 31, 2017
Care of: Seapointe Village
Job Number 3854.0006
Prepared: May 2017
Finalized: October 2017

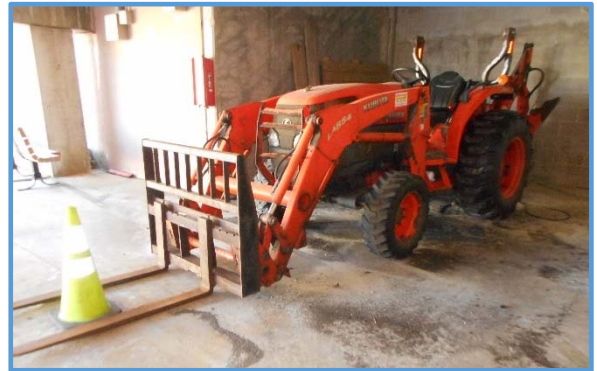
Kubota Tractor

The community utilizes vehicles in order to perform its daily maintenance functions. These vehicles were purchased at different times and experience varying degrees of usage. The remaining useful lives and estimated replacement costs are expressed in the schedule of reserve items.
